Test Report

No. SHAEC1507882803 A01

The following sample(s) was/were submitted and identified on behalf of the clients as: CABLE GLAND

Test Item: IPX8

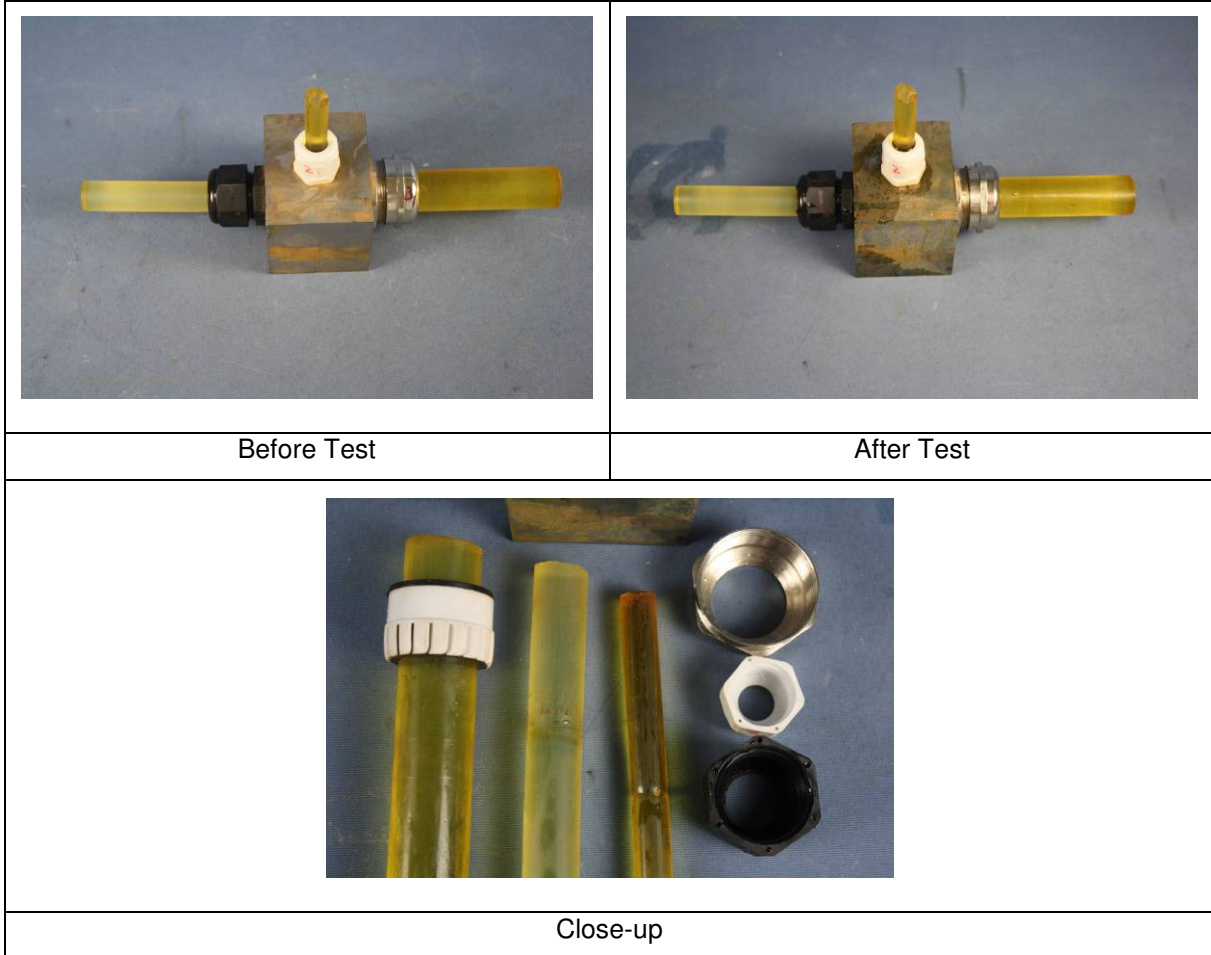
Test Photo:

Sample Description: Cable Connector

Sample	Test Result
1	No water was found inside of the sample after test.
